Safety Assessment Report

Licence holder	:	KiwiRail Network
Address	:	PO Box 593 Wellington
Type of Assessment	:	Ordinary Safety Assessment
Scope of Assessment	:	Operation of Rail Safety Management System for the National Rail System (NRS)
Assessment Standards	:	Railways Act 2005
Date(s) of Assessment	:	08 March – 12 March 2010 22 March – 26 March 2010
Assessment Team	:	John Greenland – Telarc Limited Bryan Graham – Telarc Limited Ivan Cowell – Telarc Limited John Freeman – NZ Transport Agency (NZTA) Adrian Douglas – NZTA Graeme Hudson – NZTA Anna Cleary – NZTA Merv Harvey – NZTA Rob Gould – NZTA
Licence No.	:	ORA-05-03-01
Report Issued By	:	Rob Gould
Signature	:

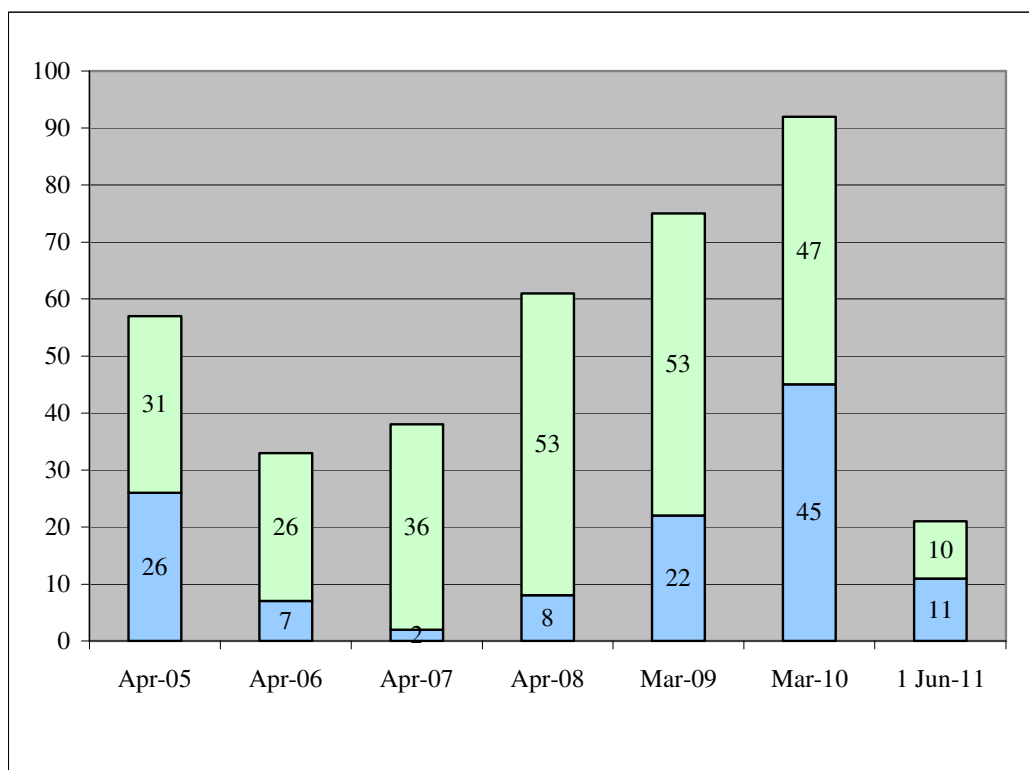
KiwiRail Network Safety System Rating

Safety system rating for conditions from the current assessment.
 Safety system rating for conditions remaining open from previous assessments.

- The overall rating has increased slightly from 75 in 2009, to 92 in 2010.
- There are 25 open conditions dating back to earlier assessments, (2 high risk, 12 medium risk and 11 low risk).
- In the latest assessment, of the 22 open conditions raised, there are 3 conditions rated as H (High Risk), 13 rated as M ((Medium Risk) and 6 rated as L (Low Risk).
